UNDERWATER BRIDGE INSPECTION REPORT

STRUCTURE NO. 27549

42ND AVENUE

MISSISSIPPI RIVER

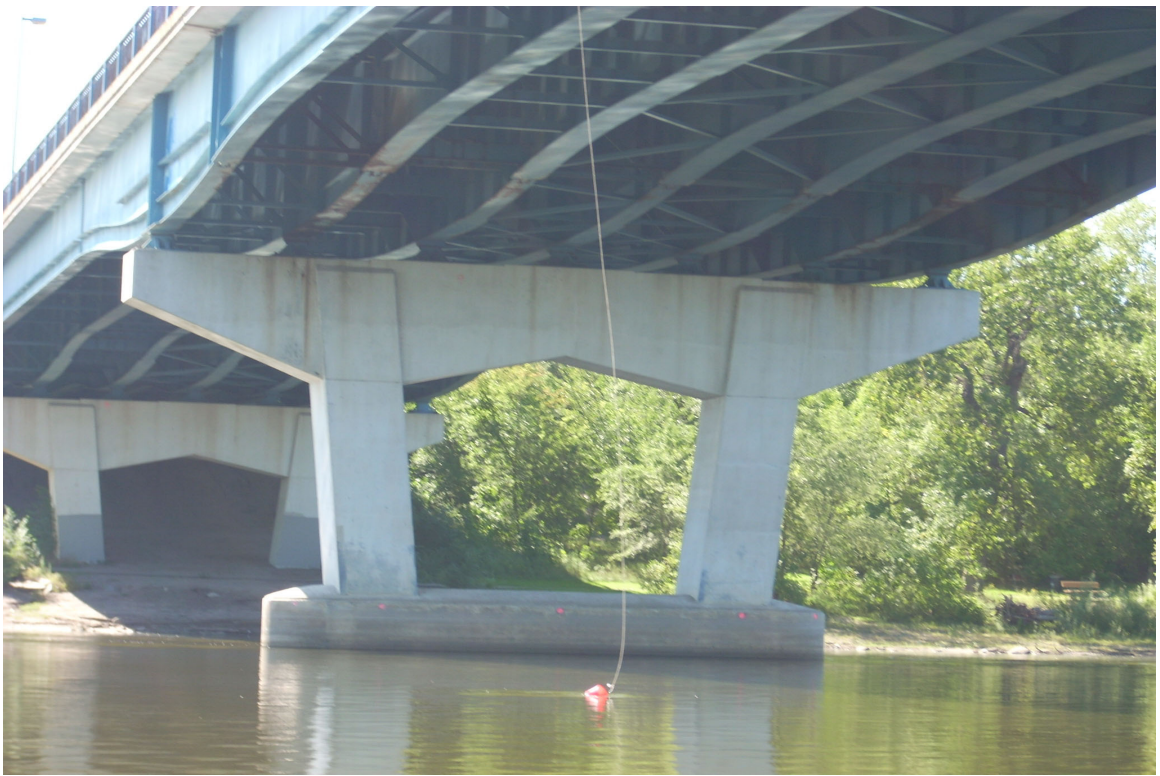
Photograph 2. View of Pier 9, Looking Northwest.

- 2 The top of the footing around the entire perimeter of Pier 9 was exposed with vertical face exposures of 1 foot at the upstream west corner, 4 inches at the downstream west corner, and a maximum of 2.5 feet along the east face.

- 3 An 18 inch diameter log was observed on the channel bottom at the upstream end of Pier 9.
- 4 A log that was 18 inches in diameter and 30 feet long was observed on the channel bottom along the east face of Pier 9.

Monitor the timber debris at Pier 9 and 10, and if found to be increasing in the future, removal operations may become warranted.

Monitor the footing exposure at Pier 9 during future underwater inspections. The scour evaluation indicates pier foundations are stable for the calculated scour conditions.

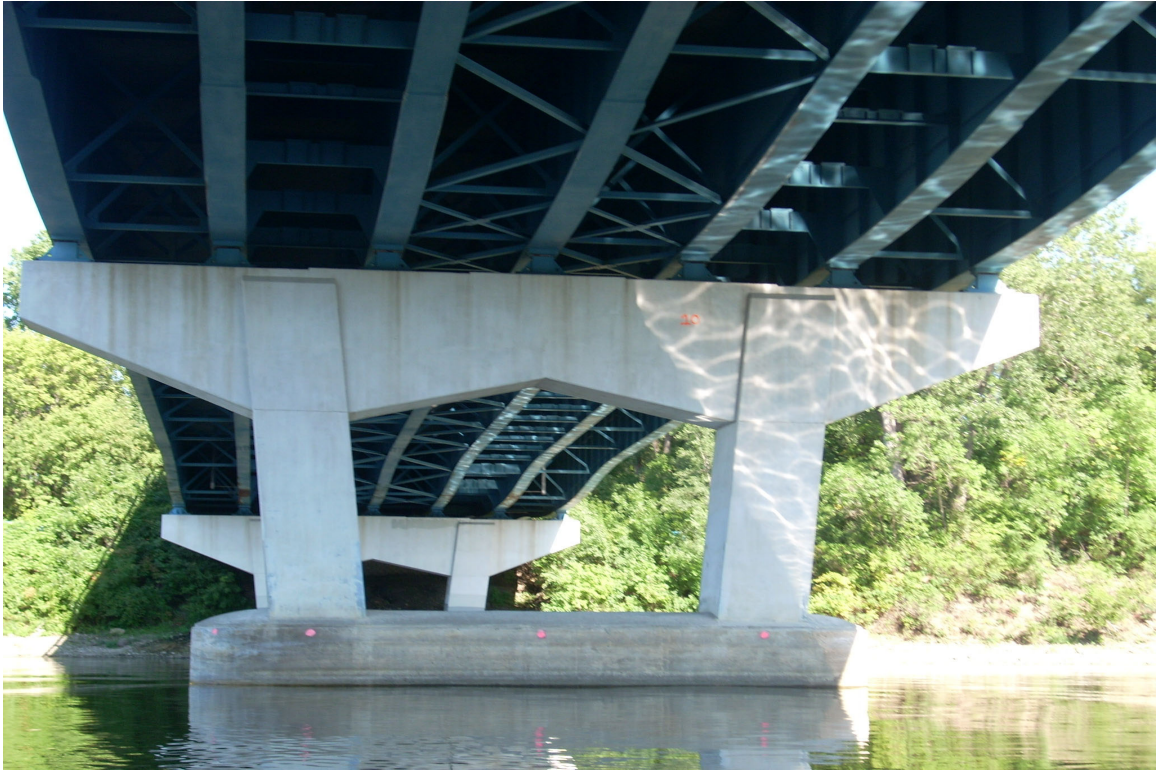
Photograph 3. View of Pier 10, Looking Southeast.

- 7 A vertical crack that was up to 1/8 inches wide was observed extending from the top of the webwall to the waterline.
- 8 Overall concrete on Piers 9 and 10 was smooth and sound with some random minor poor consolidation with 1/4 inch maximum penetration.

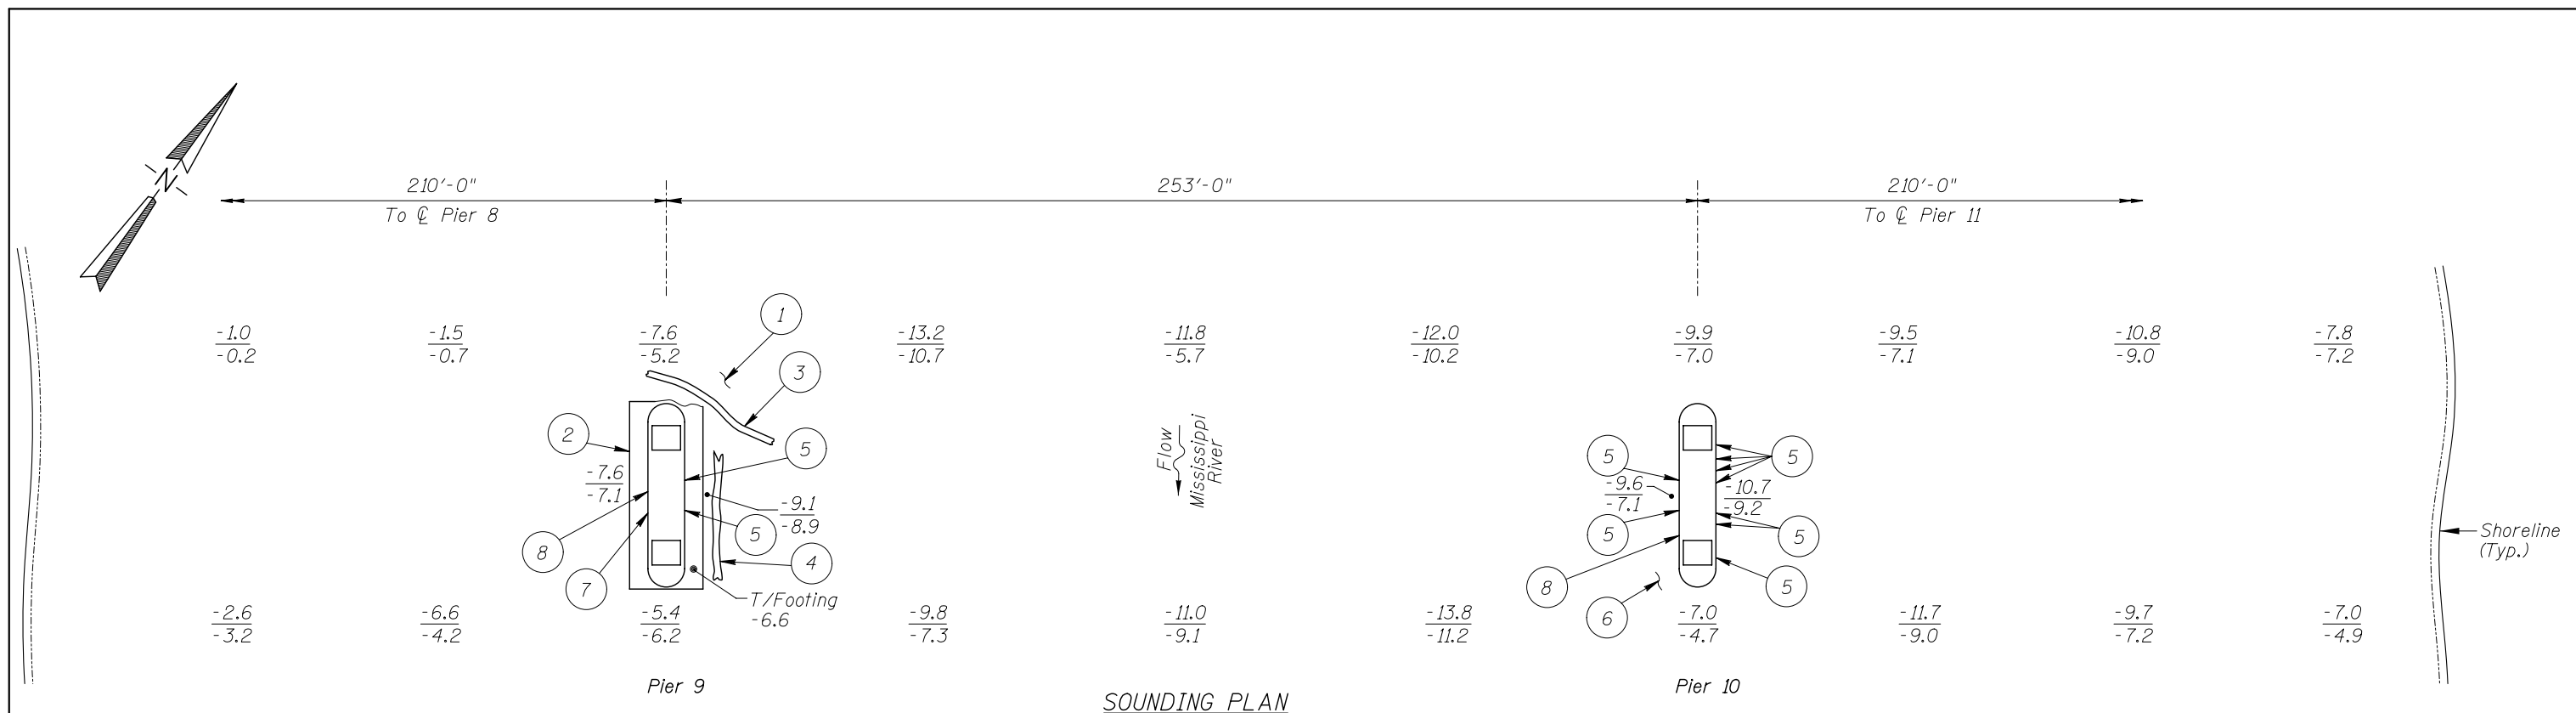
SOUNDING PLAN

- 1 The channel bottom material around Pier 9 consisted of riprap up to 1 foot in diameter at the upstream nose and sand infilling around the rest of the pier that had up to 1.5 foot of probe rod penetration.

- 5 A vertical hairline crack was observed extending from the top of the webwall to the waterline.
- 6 The channel bottom material around of Pier 10 consisted of 1 to 3 foot diameter riprap with sand infilling that had up to 8 inches of probe rod penetration.
